TECHNICAL REPORT HL-90-19

# A STUDY OF VEGETATION ON REVETMENTS SACRAMENTO RIVER BANK PROTECTION PROJECT

## PHASE 1

## LITERATURE REVIEW AND PILOT STUDY

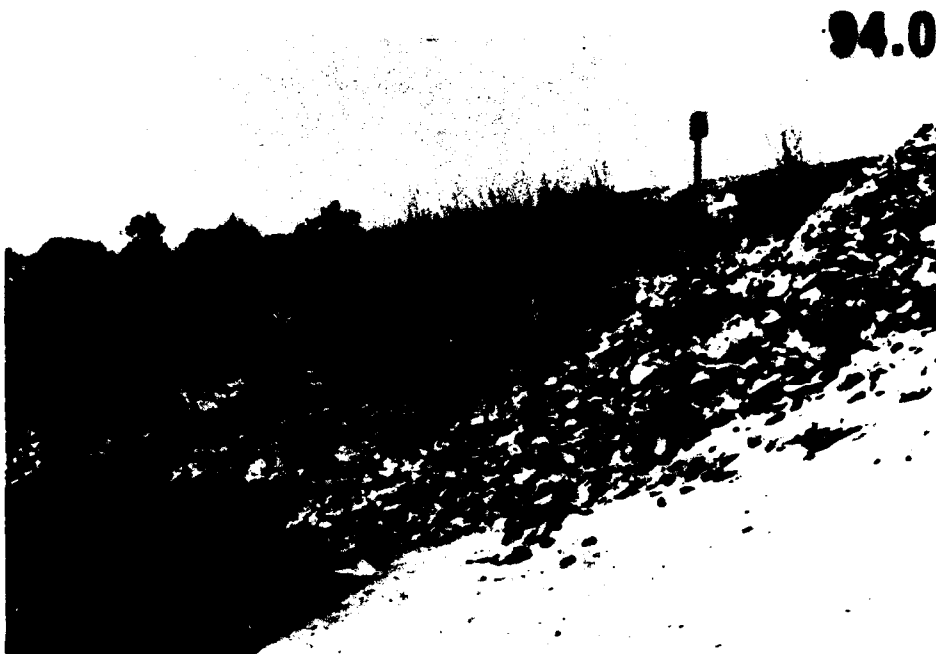
c. RM 94.0L

Figure 20. (Sheet 2 of 3)

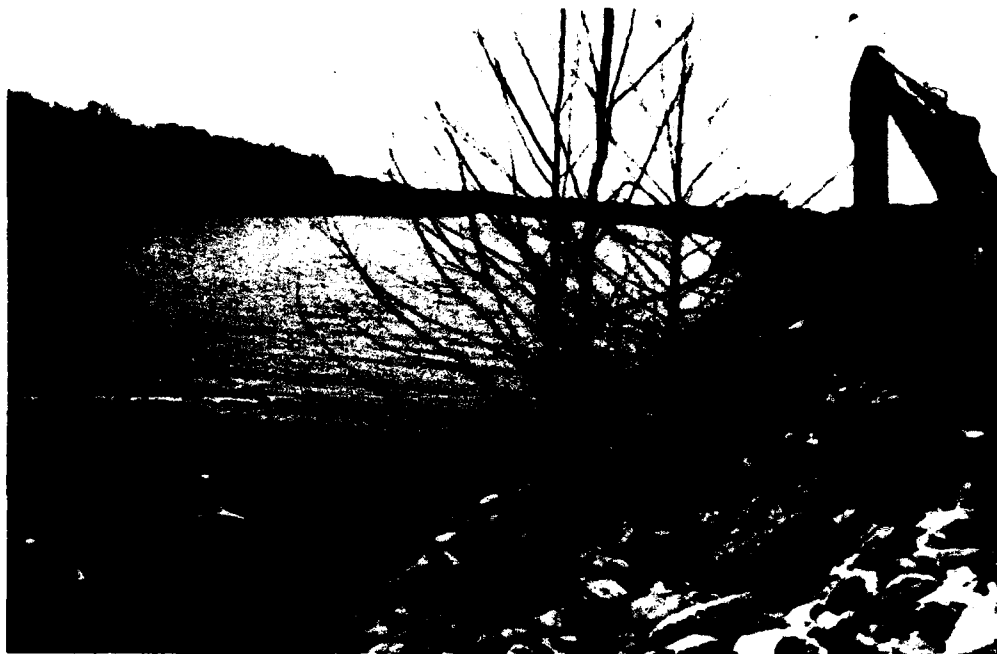
Figure 33. Tree growing in riprap slope protection, Divide  
Section, Tennessee-Tombigbee Waterway, Mississippi
